Known Issues

Summary of Known Issues Associated with Serial Solutions 6.2

Version: 1.0

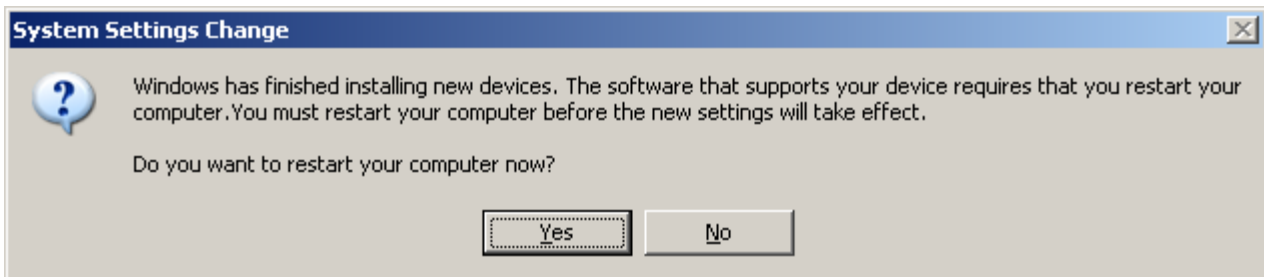
4.1. Systems Settings Change

When our cards are installed on a Server, a message may be displayed saying that the Server will need to be restarted.

In a test environment, this issue is found to not be present when the modem and telephone logging device, normally connected to the onboard com ports of the Server, are detached. This indicates that the issue is due to the interaction of the serenum upper filter driver (which ships with the Operating System) when enumerating the modem / telephone logging device. It is serenum on our serial port that is in a state which makes the system think it needs a reboot.
